# HISTORIC PROPERTY INVENTORY FORM

Field Site No. 3727 OAHP No. \_\_\_\_\_ Date Recorded 28 Dec 1995  
Site Name Historic Classified Storage Facility Revised 29 May 1998  
Common \_\_\_\_\_  
Field Recorder B. White, I. Lindsay, J. Keating  
Owner's Name U.S. Department of Energy, Richland Operations Office  
Address P.O. Box 550  
City/State/Zip Code Richland, WA 99352

Address Building 3727, 300 Area  
City/Town/County/Zip Code Richland/Benton County/99352  
Twp 10 N Range 28 E Section 11 1/4 Section NW 1/4 1/4 Sec \_\_\_\_\_  
Tax No./Parcel No. \_\_\_\_\_ Acreage \_\_\_\_\_  
Quadrangle or map name Richland, Washington Quad. - 7.5 min series 1992  
UTM References Zone 11 Easting 324460 Northing 5137860  
Plat/Block/Lot \_\_\_\_\_  
Supplemental Map(s) \_\_\_\_\_

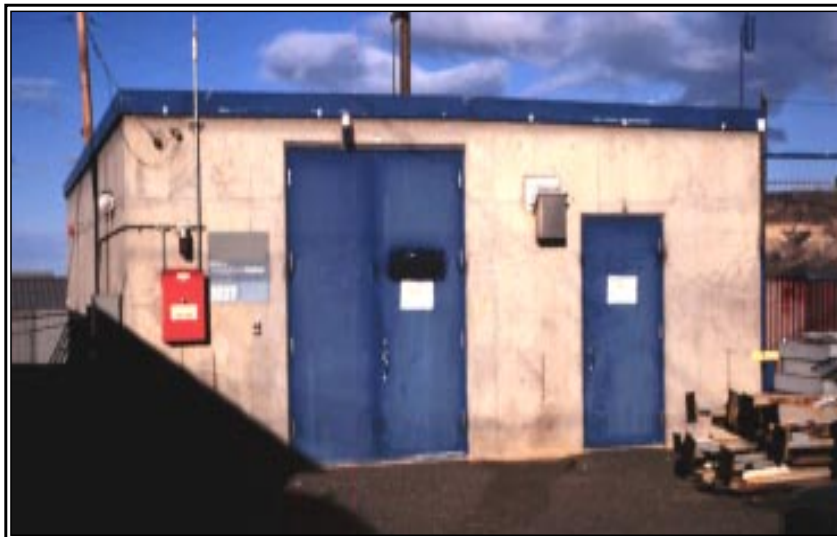
Photo at right; Roll 183, Frame 26  
view of south facade

Building 3727 is a concrete block structure with a concrete floor and flat roof. The building dimensions are 37.1 ft. by 23.2 ft. The walls are one foot thick concrete and the building sits on a poured concrete foundation. The south wall contains a tall metal double door which leads to the vault and vault foyer, and a single metal door leading to the mechanical/electrical room. The west wall has no distinct features other than a metal electrical box. The east wall also contains a metal electrical box and a few metal pipes connecting in various locations to the building. The north wall has no distinct features. This building contains no windows.
